Report Date August 4, 2022
Report Number 2206243
Purchase Order Number E40005287

Test Report

GenerEl PCBA Type 404

Visual Inspection, X-ray Inspection, Dye and Pull Inspection,
And Cross Section of Solder Joints

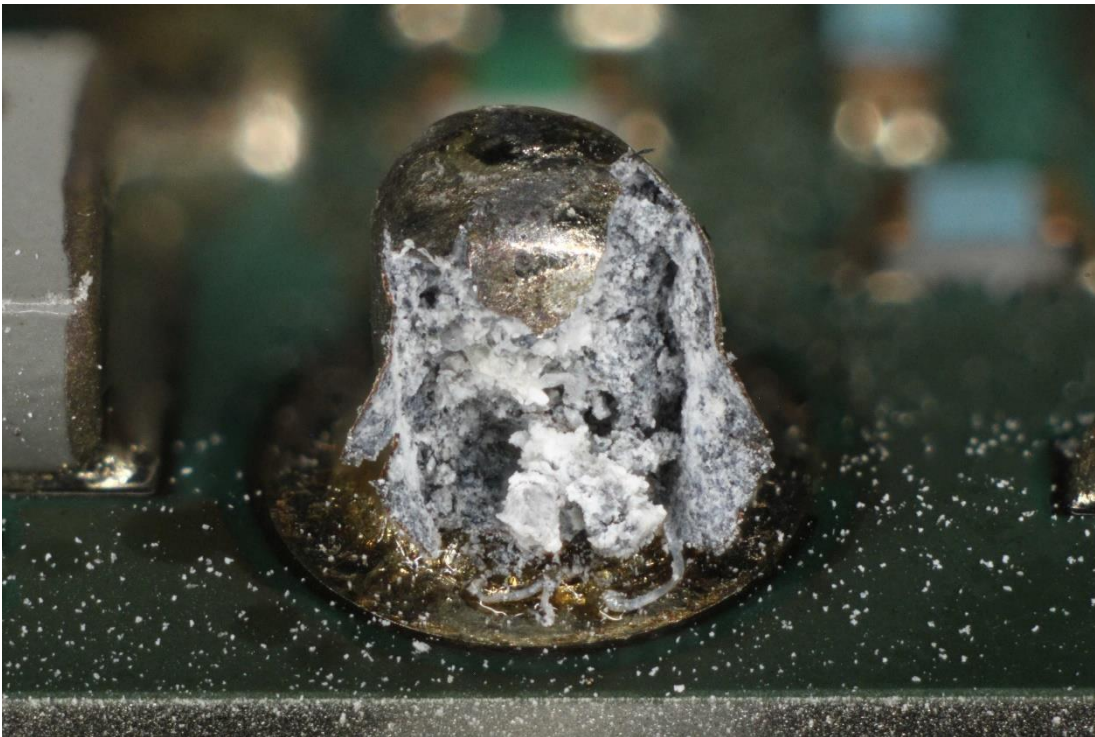
The BNC connector has a corroded mounting lug, shown in Figure 3.

The corrosion shown in Figure 3 does not meet the requirements of GenerEl42, and does not meet Class 3 requirements of IPC-A-610H 10.6.4 Cleanliness – Surface Appearance. The solder joints otherwise meet IPC-A-610H Class 3 requirements.

The corrosion shown in Figure 3 does not meet the requirements of GenerEl42, and does not meet Class 3 requirements of IPC-A-610H 10.6.4 Cleanliness – Surface Appearance.

Figure 3. Specimen 4LP1 Visual inspection. Corroded magnesium BNC connector mounting stud.

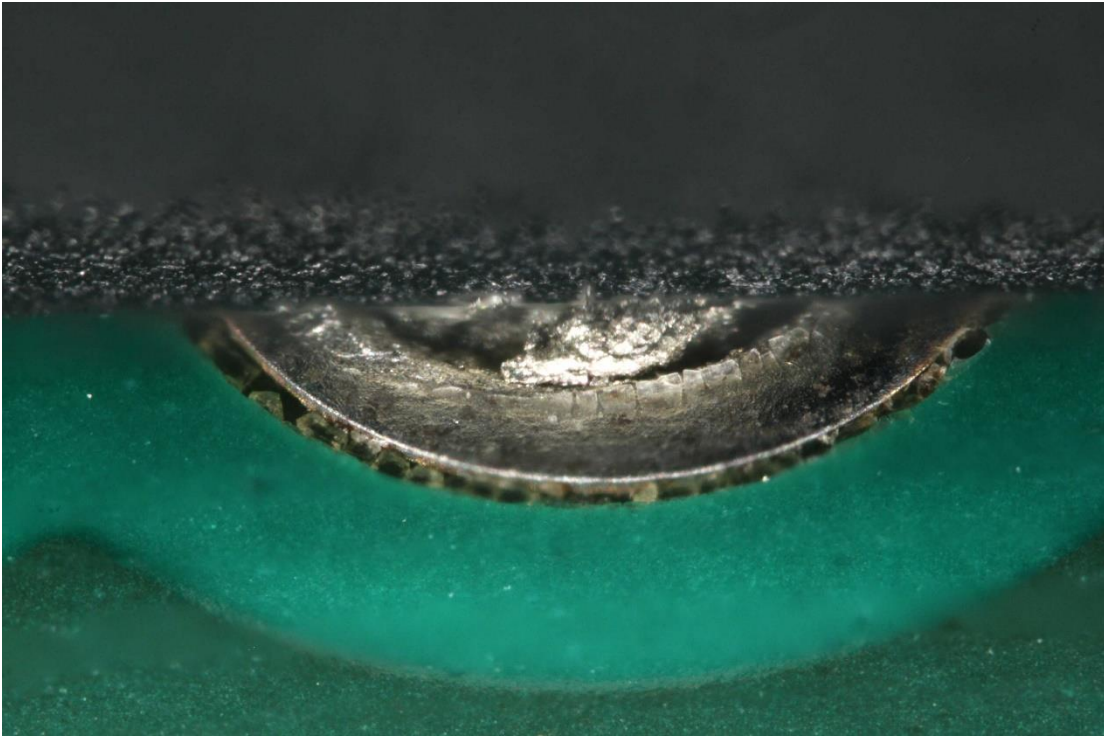
Specimen 4LP1 has a cracked PTH solder joint. See Figure 4.

Figure 4 shows a cracked solder joint which does not meet the Class 3 requirements of IPC-A-610H 5.2.10 Soldering Anomalies – Fractured Solder.

The cracked solder shown in Figure 4 does not meet the Class 3 requirements of IPC-A-610H 5.2.10 Soldering Anomalies – Fractured Solder.

Figure 4. Specimen 4LP1 Visual inspection. Cracked solder visible beneath the component housing.

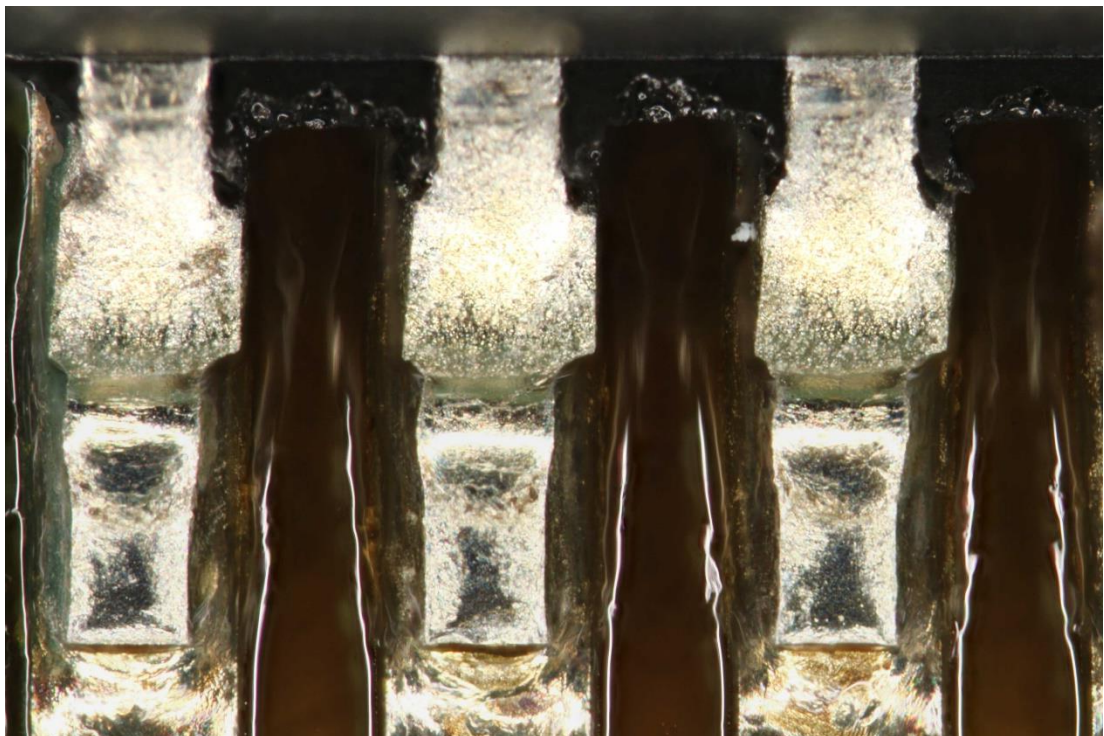
Figure 5. Specimen 4LP1 IC4 Visual whisker inspection. The visual inspection located the whisker that is shown in the next image.

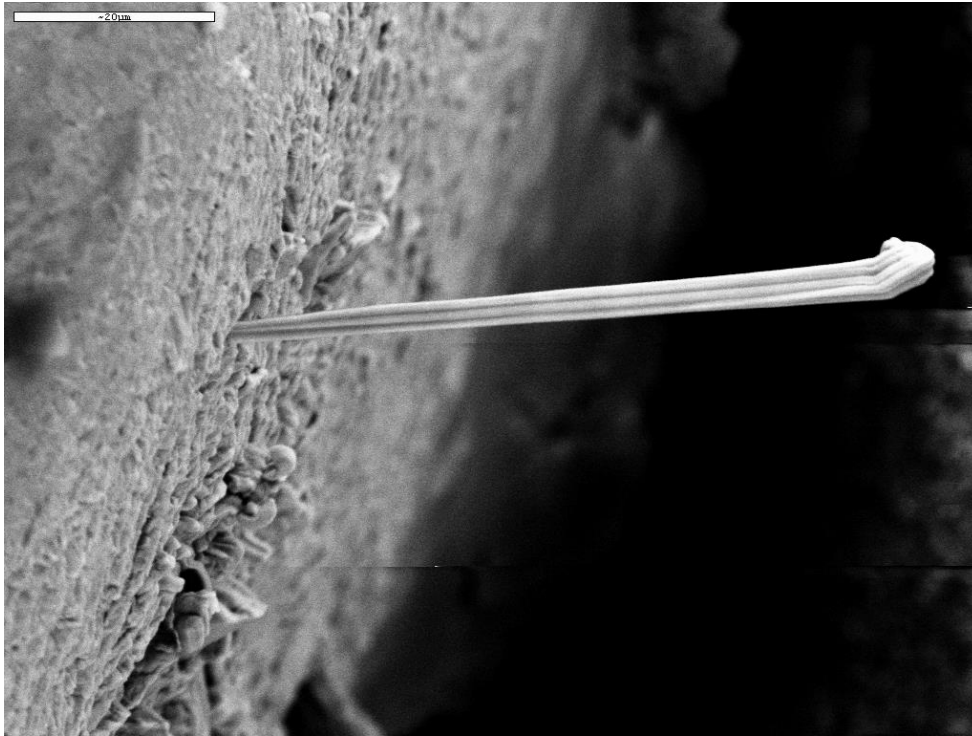
A tin whisker was observed on a component lead of IC4 and is shown in Figure 6.

Figure 6. Specimen 4LP1 IC4 SEM whisker inspection. This whisker was observed on the leads of IC4.

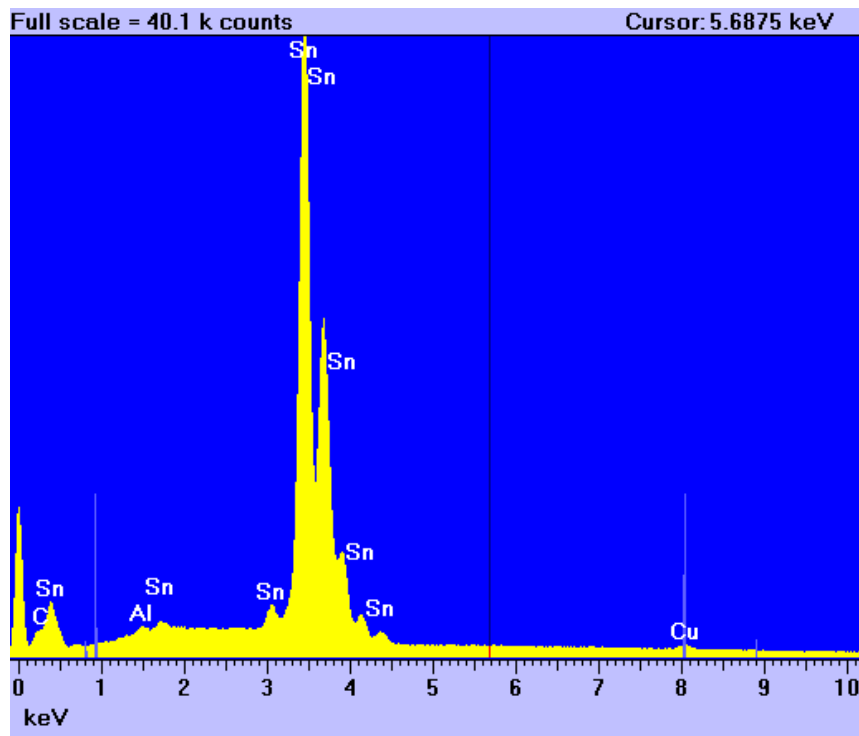
Figure 7. Specimen 4LP1 Spectrum of the tin whisker that is shown in Figure 6. This spectrum confirms the whisker is pure tin.

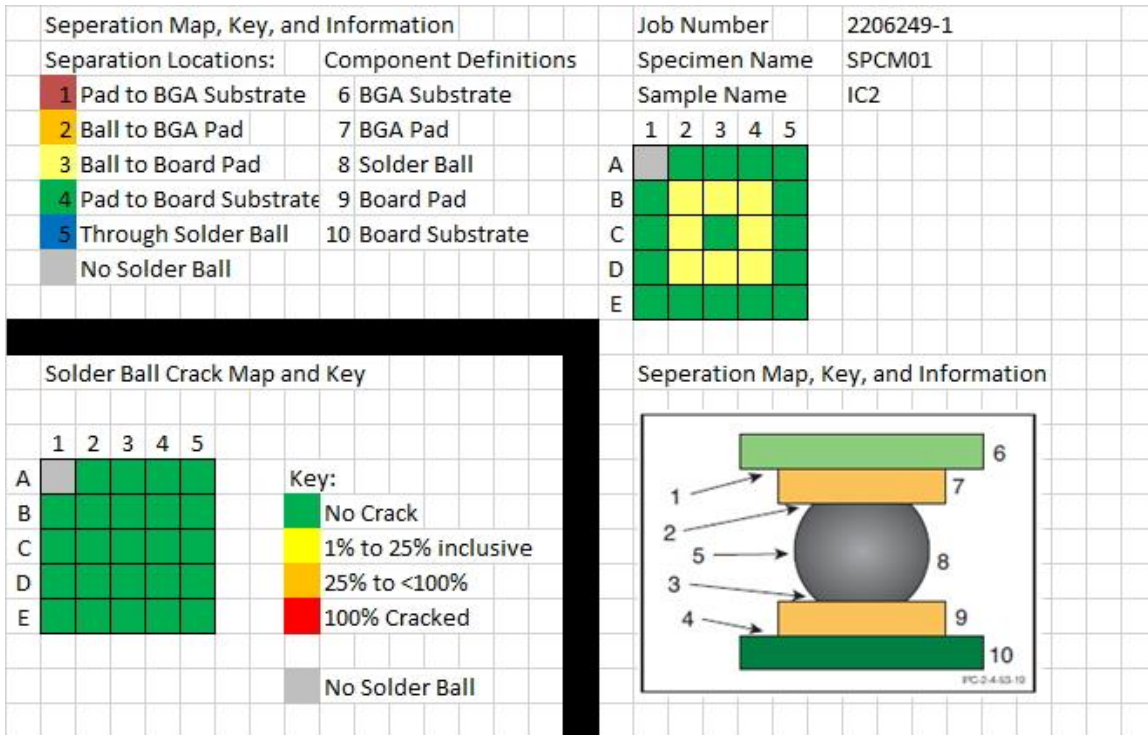
There were no fractured solder balls and no crack was detected.

Figure 11. Specimen 4LP1 IC2 Crack and separation Map.

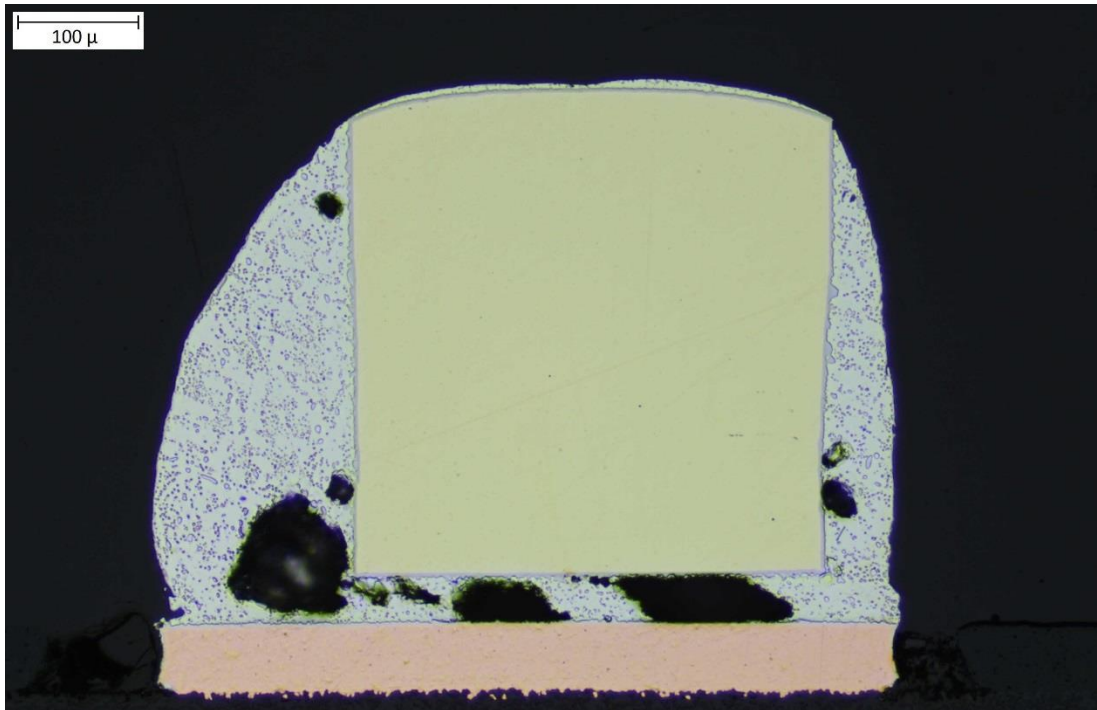
Figure 14. Specimen 4LP1 J4 leg 08. This solder joint's cross-sectional area is 19.6% void.

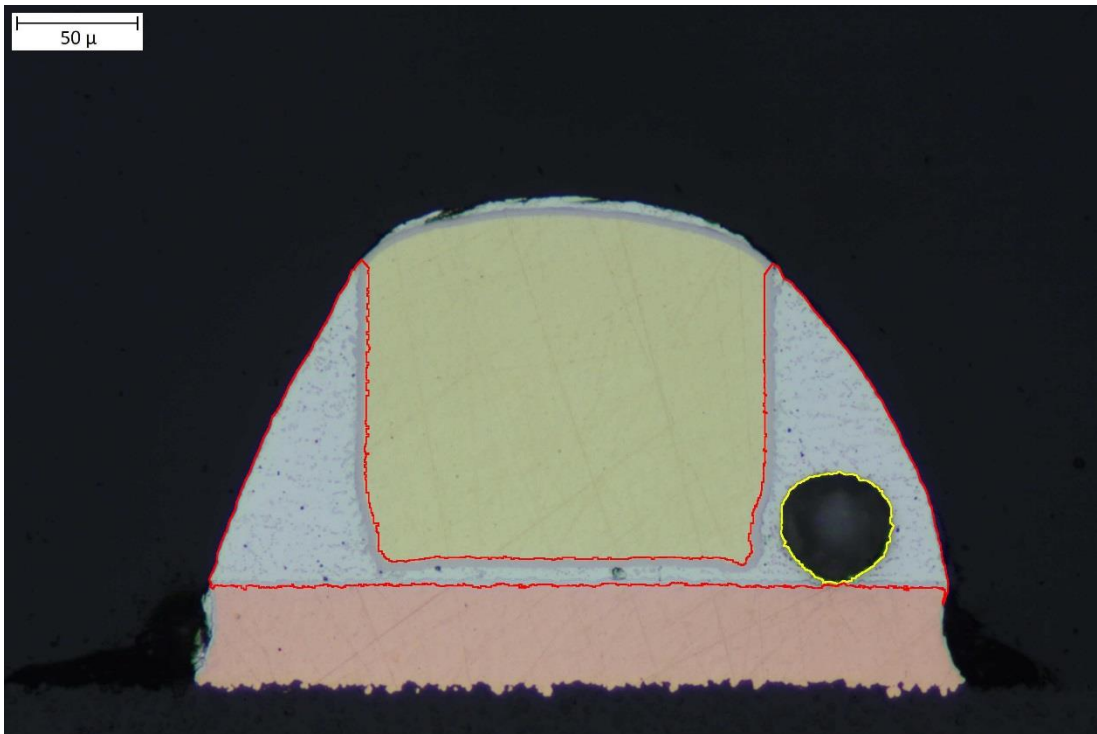
Figure 15. Specimen 4LP1 J4 Leg 04. This solder joint's cross-sectional area is 12.9% void. The solder joint is outlined in red and the solder voids are outlined in yellow to demonstrate Elmet's void measurement procedure. Outlines are not typically included in reports. See Figures 14 and 31 for typical examples.

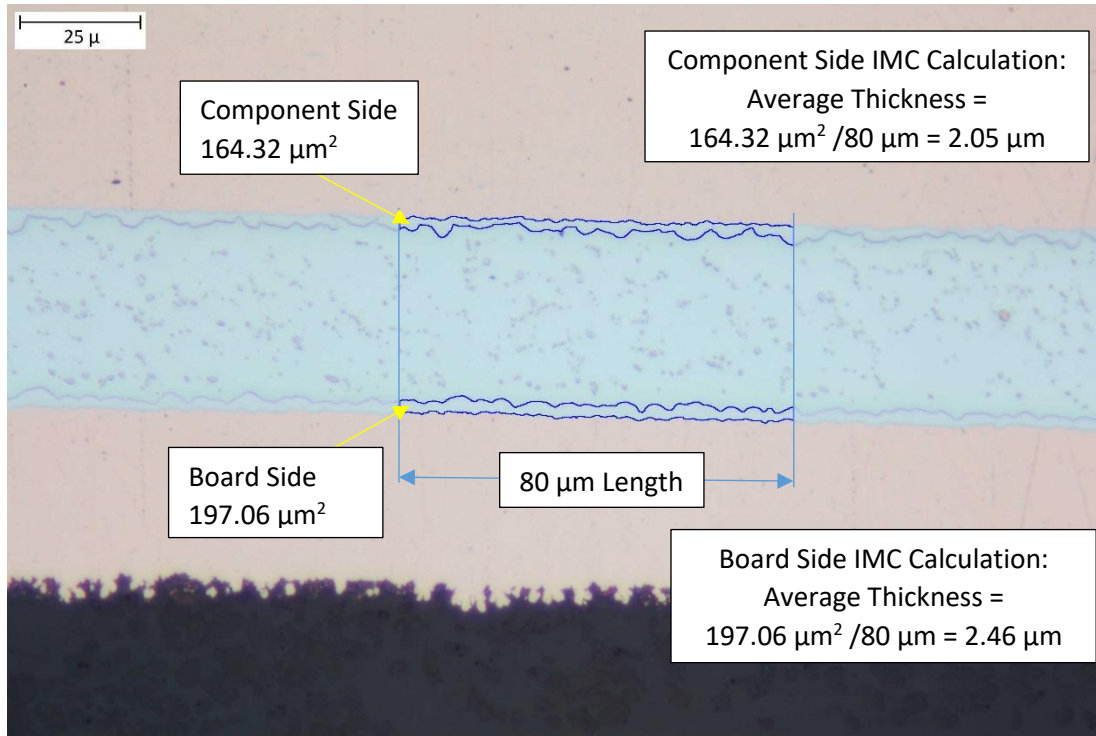
The intermetallic layers are continuous and have reasonably uniform thickness. The Intermetallic layers are thicker than 1 μm and thinner than 6 μm , and meet the specifications set in GenerEl42.

Figure 16. Specimen 4LP1 J4 Leg 04. Optical IMC measurement. The outlines are 80 microns in length.

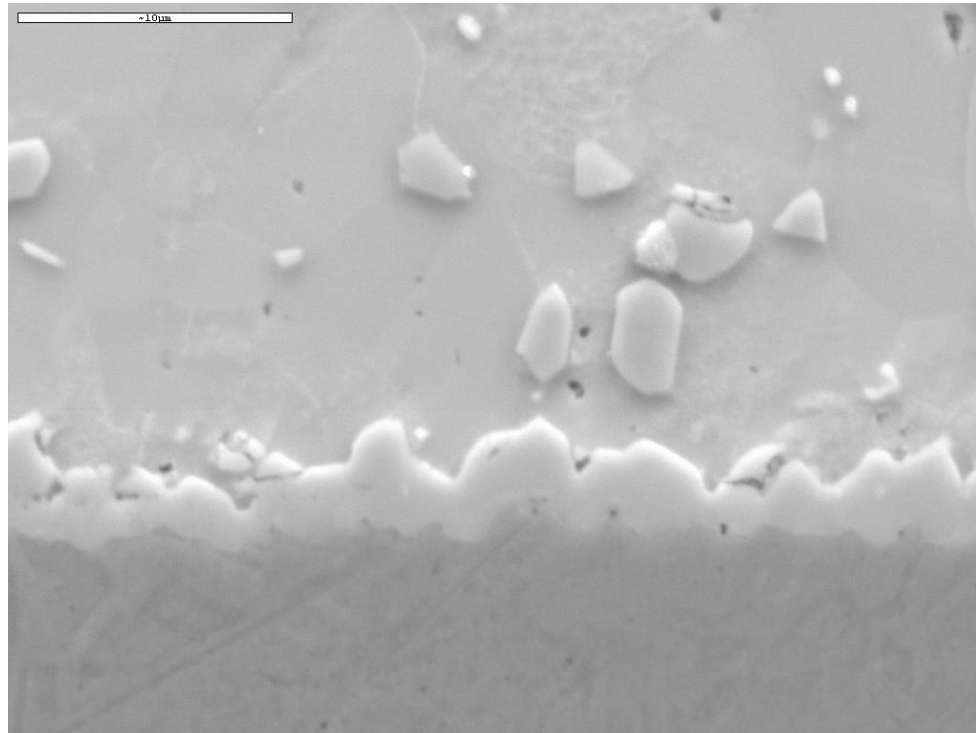
Figure 17. Specimen 4LP1 J4 Leg 06. SEM IMC measurement, solder to board. Elmet averages the IMC layer thickness in 6 locations to obtain an IMC thickness value. This IMC layer thickness averages 2.84 microns.

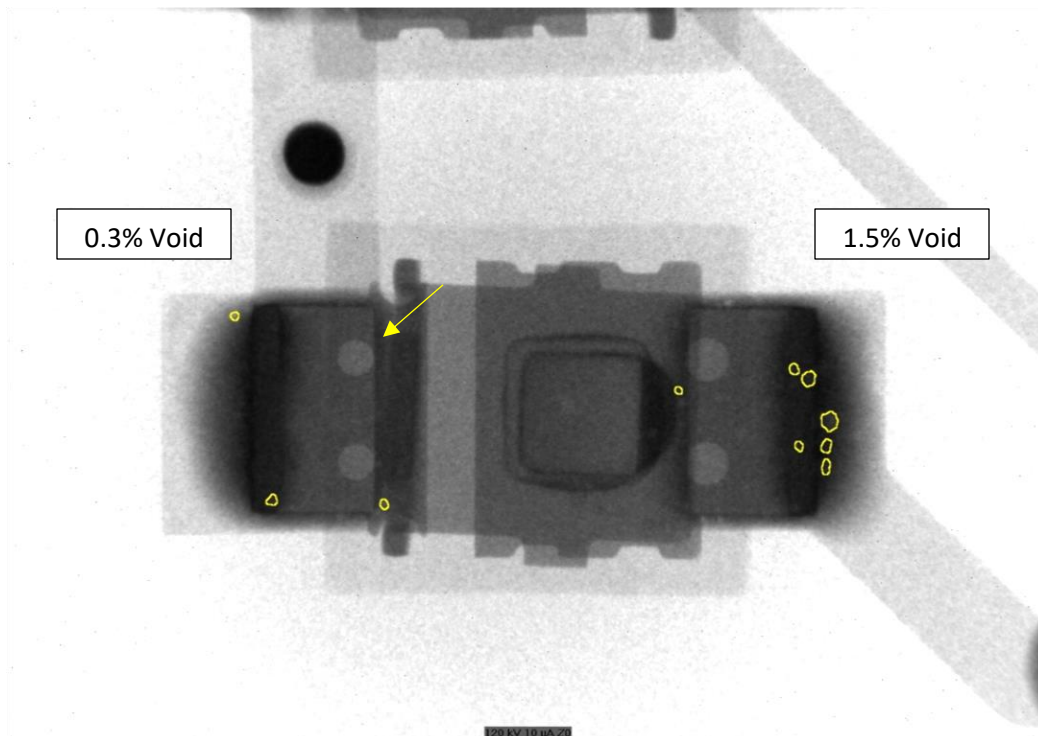
The X-ray image of D2 is presented in Figure 19. Elmet examined the X-ray image for insufficient solder, displaced components, lead overhang, solder balls, and any other unusual or unexpected feature. No insufficient solder, displaced component, lead overhang, solder balls, or other unusual feature was observed.

Elmet measured the void fraction of the D2 solder joints. The measurements are included in Figure 19 and in Table 2, below.

Solder voiding does not exceed the specification limits.

Figure 19. Specimen 4LP1 D2 X-ray. The yellow circles are voids. The four circles that are not outlined, such as the one indicated by the yellow arrow, and internal features of D2 and not voids.

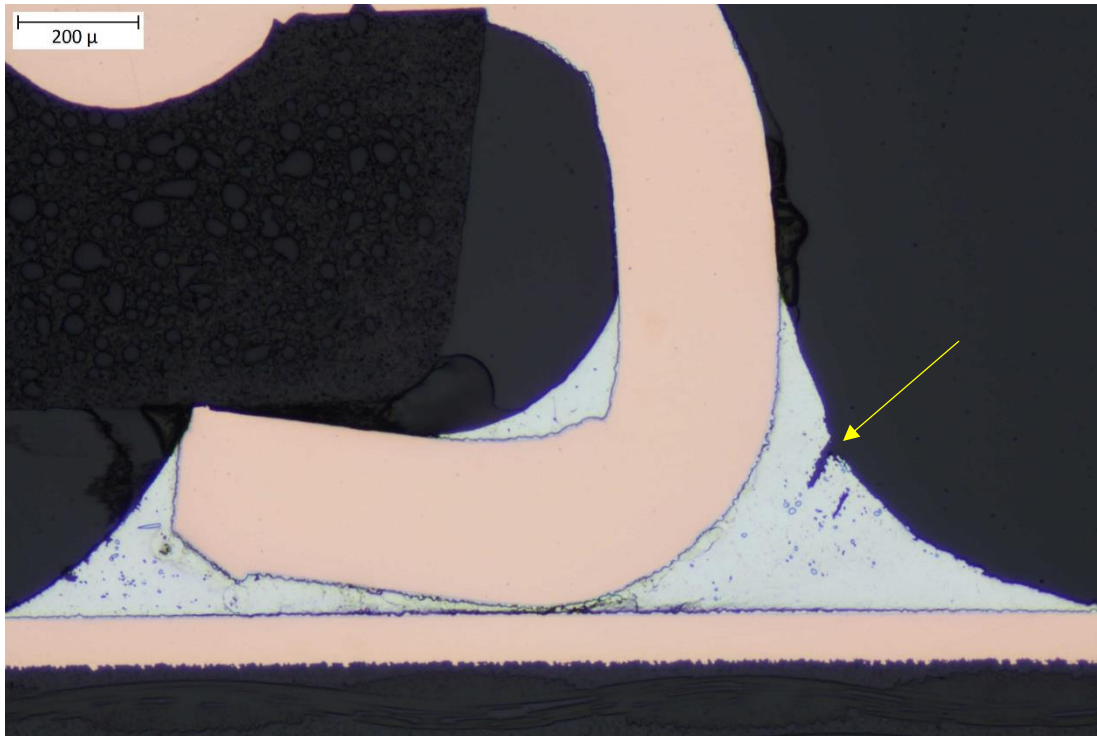
A hot tear was observed in a D2 solder joint. This is permitted by IPC-A-610H section 5.2.13 Solder Anomalies and is reported as a feature of interest.

Figure 22. Specimen 4LP1 D2. The yellow arrow points to a hot tear. Hot tears are not cracks.

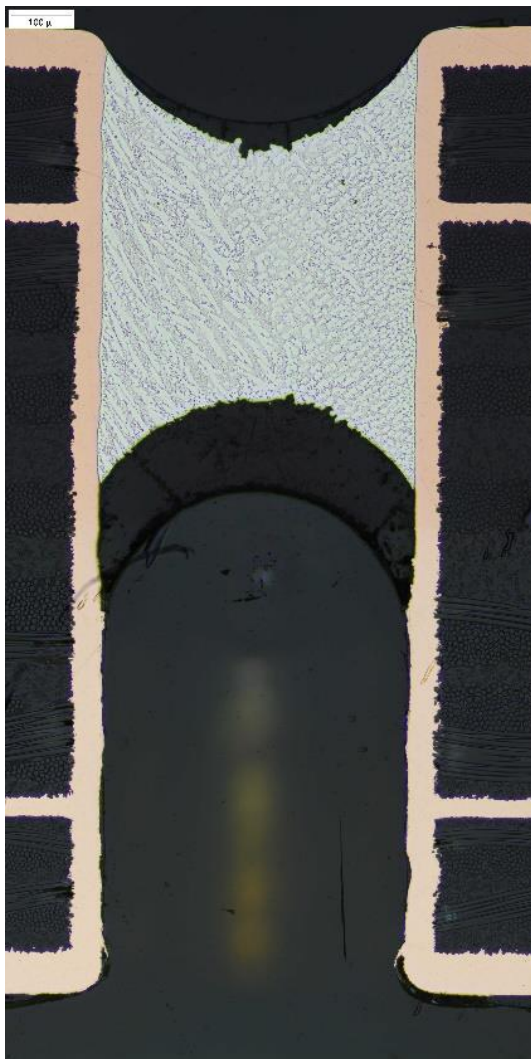
The platings have uniform thicknesses. No voids, nodules or cracks were observed. The average plating thicknesses exceed 25 micrometers, and the minimum thicknesses exceed 20 micrometers. Through hole plating meets the requirements of GenerEl42.

Figure 25. Specimen 4LP1 Vias. No plating cracks, no voids, no nodules, no intrusions. Reasonably uniform plating thickness.

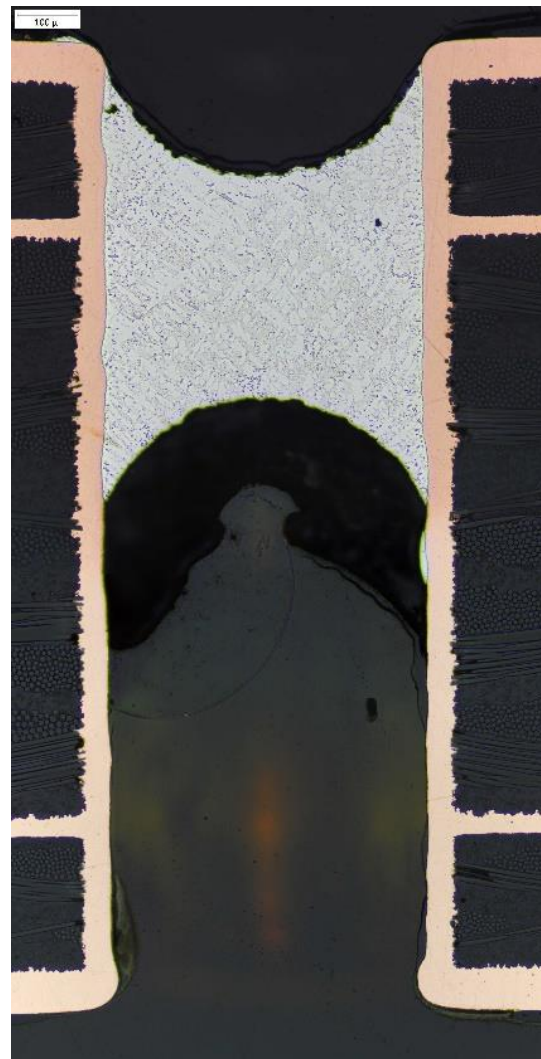
Figure 26. 103 Specimen 4LP1 Vias. No plating cracks, no voids, no nodules, no intrusions. Reasonably uniform plating thickness.

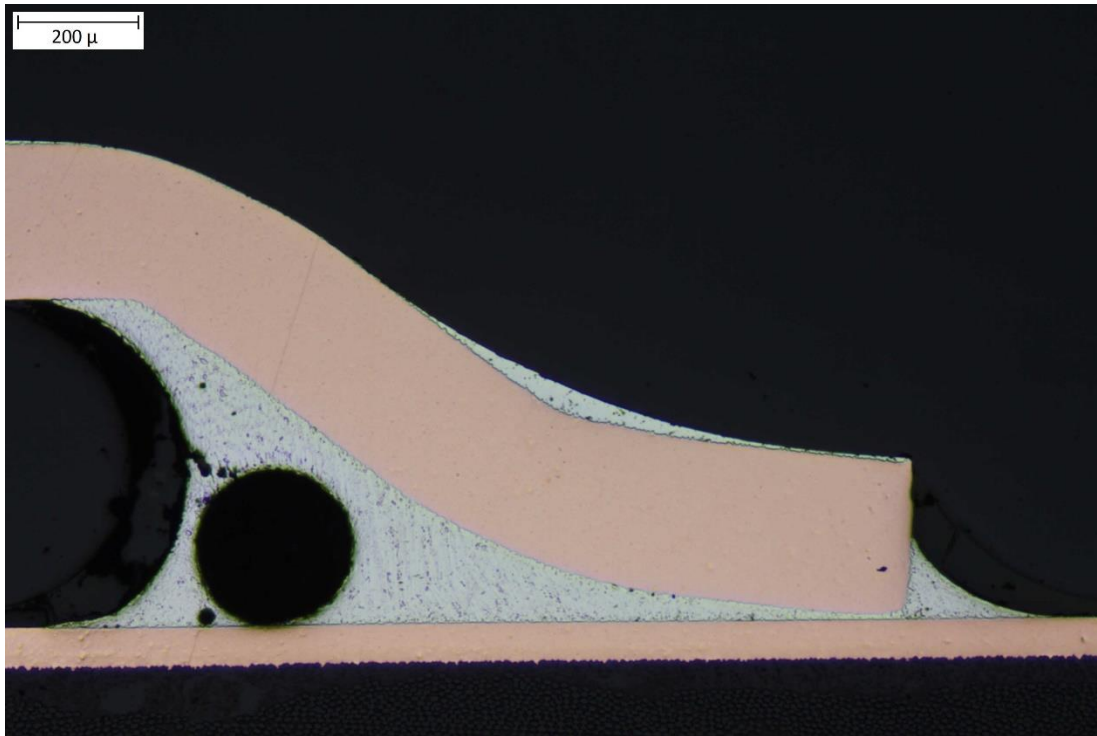
One solder joint contains voids exceeding 25% of its cross-sectional area. See Figures 31 and 32. This does not comply with the requirements of GenerEl42.

Figure 31. Specimen 4LP1 T101. This solder joint's cross-sectional area is 27.1% void. Typical Brightfield image used for most inspection work and reporting. Compare with Figure 32.

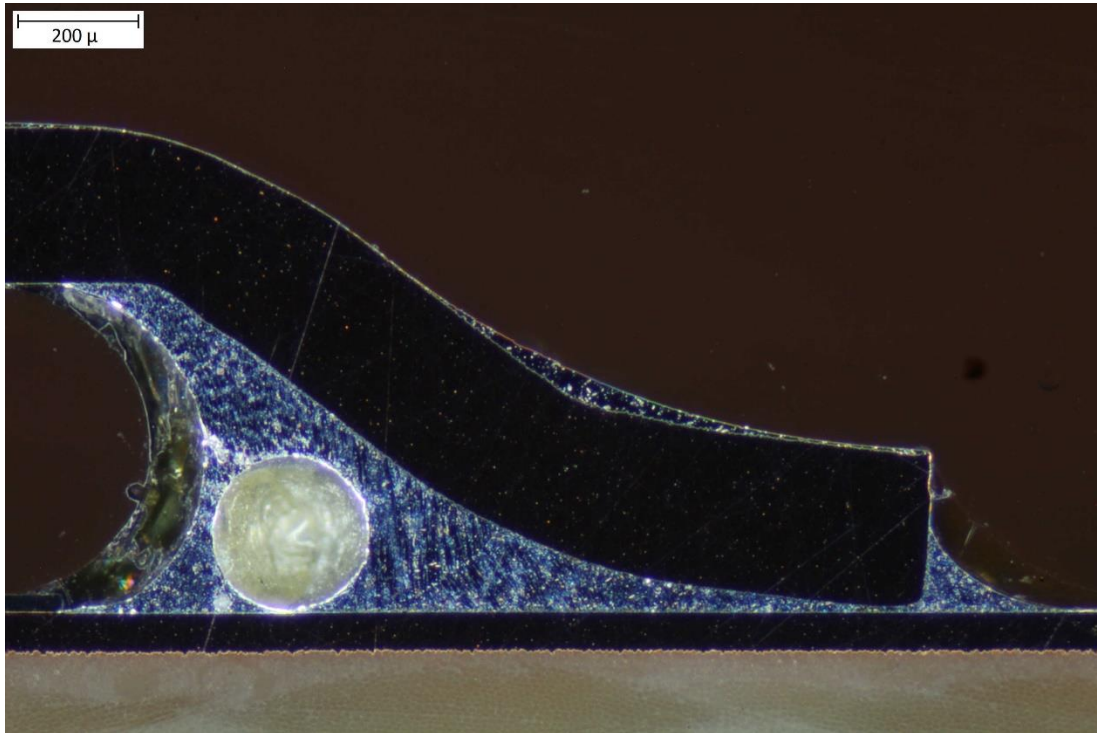
Figure 32. Specimen 4LP1 T101. Darkfield image. Darkfield imaging can reveal features not visible in brightfield. Compare with Figure 31.

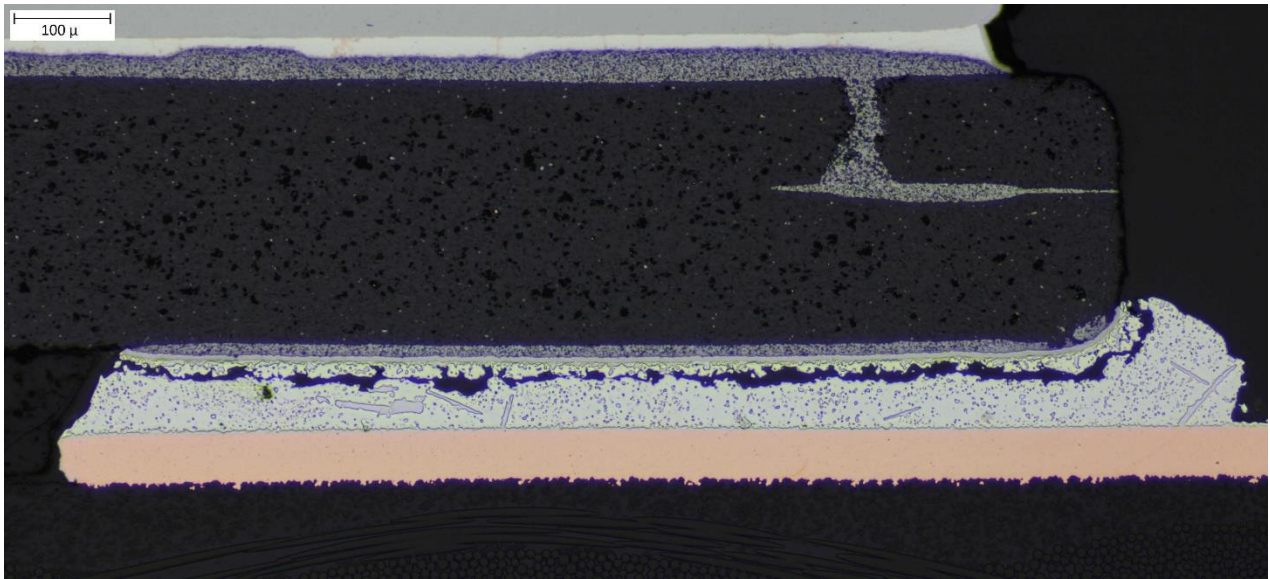
Cross sectioning revealed three solder cracks. All three solder cracks exceed 25% of the length of the solder joint. Two of the solder joints are completely cracked, or fractured. See Figures 35 and 40.

Figure 35. Specimen 4LP1 D313 Pin 1. This solder joint is 100% cracked.

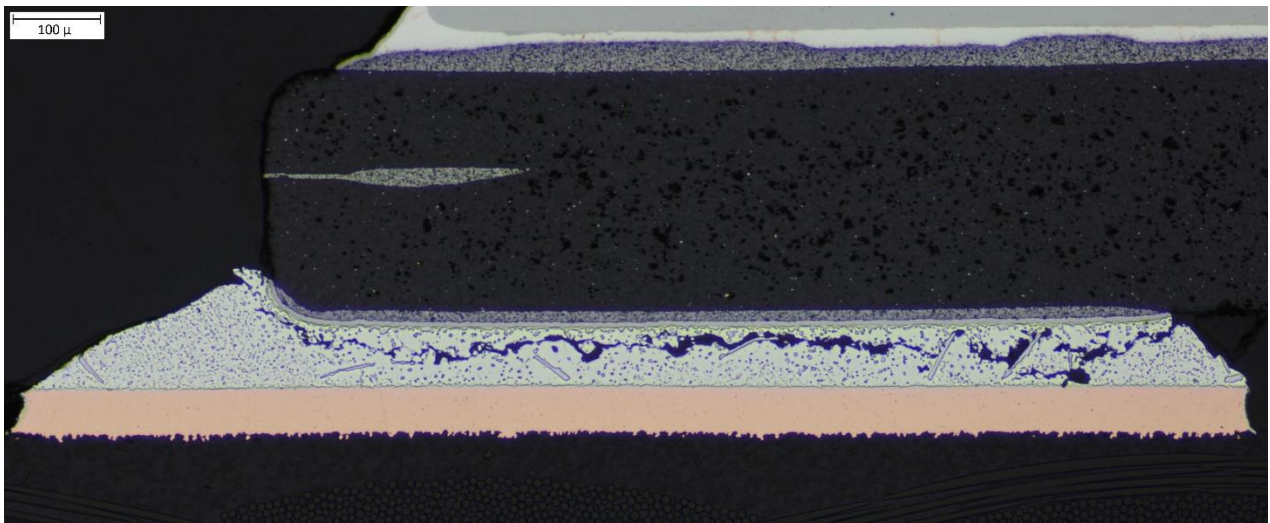
Figure 36. Specimen 4LP1 D313 Pin 2. This solder joint is 99.4% cracked.

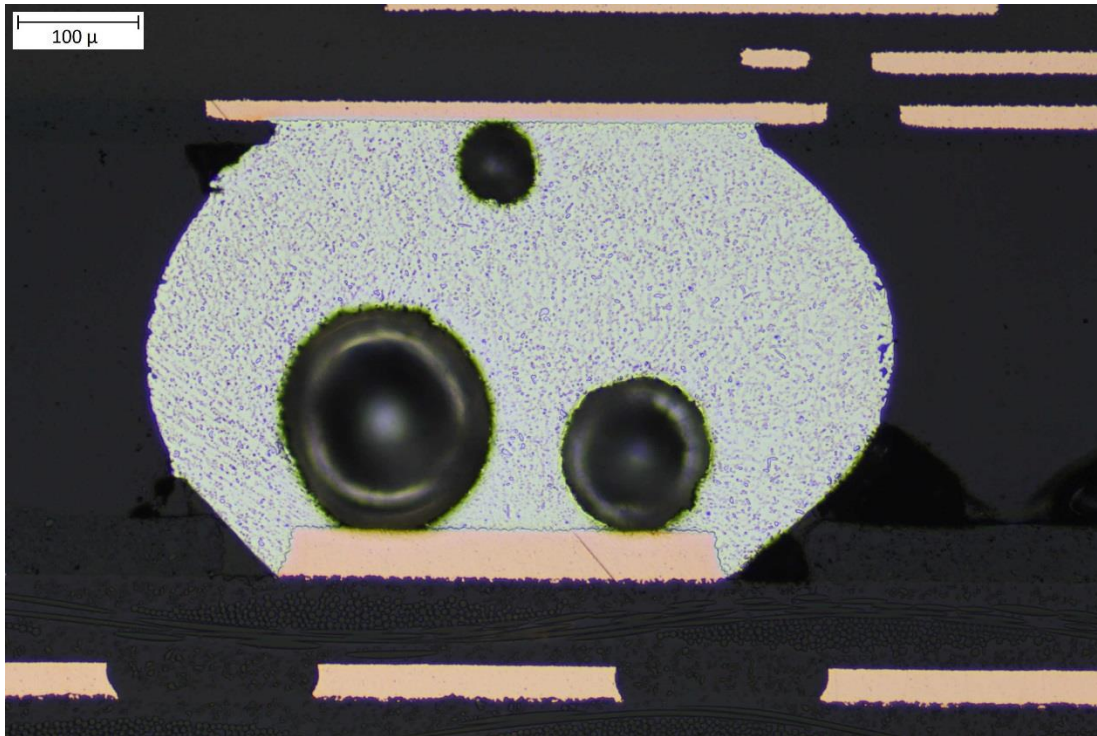
Figure 39. Specimen 4LP1 IC3 Row 01 Solder ball B. This solder joint's cross-sectional area is 22.8% void.

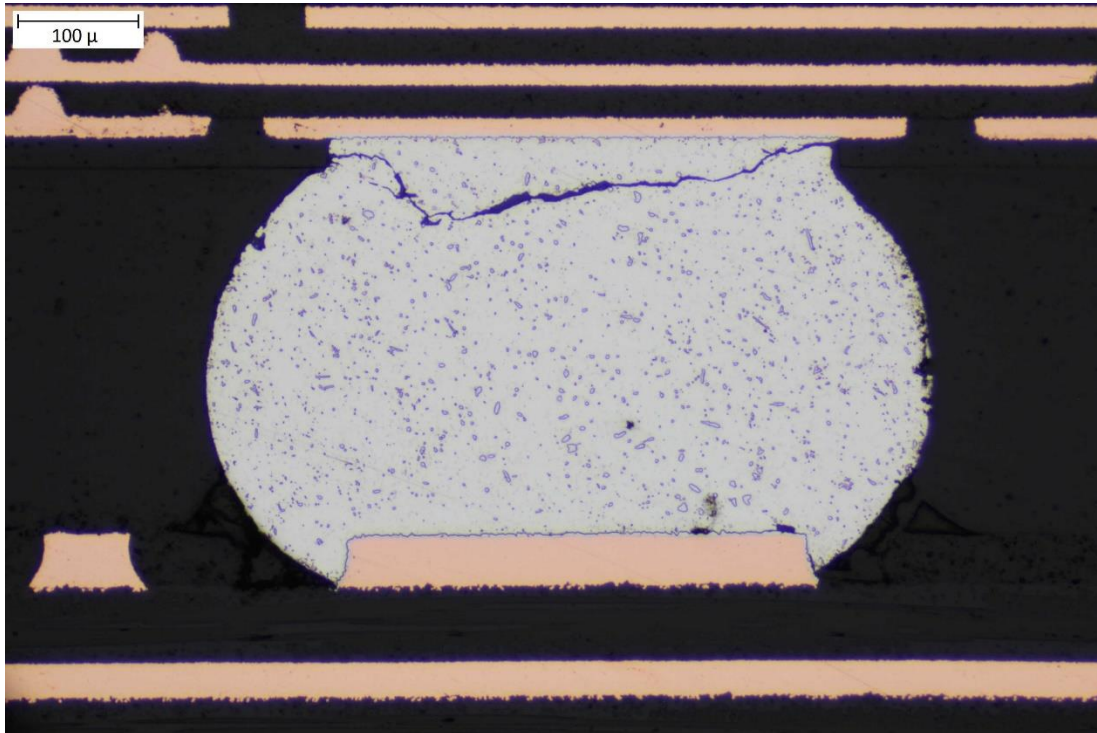
Figure 40. Specimen 4LP1 IC3 Row 01 Solder ball E. This solder joint is 100% cracked.

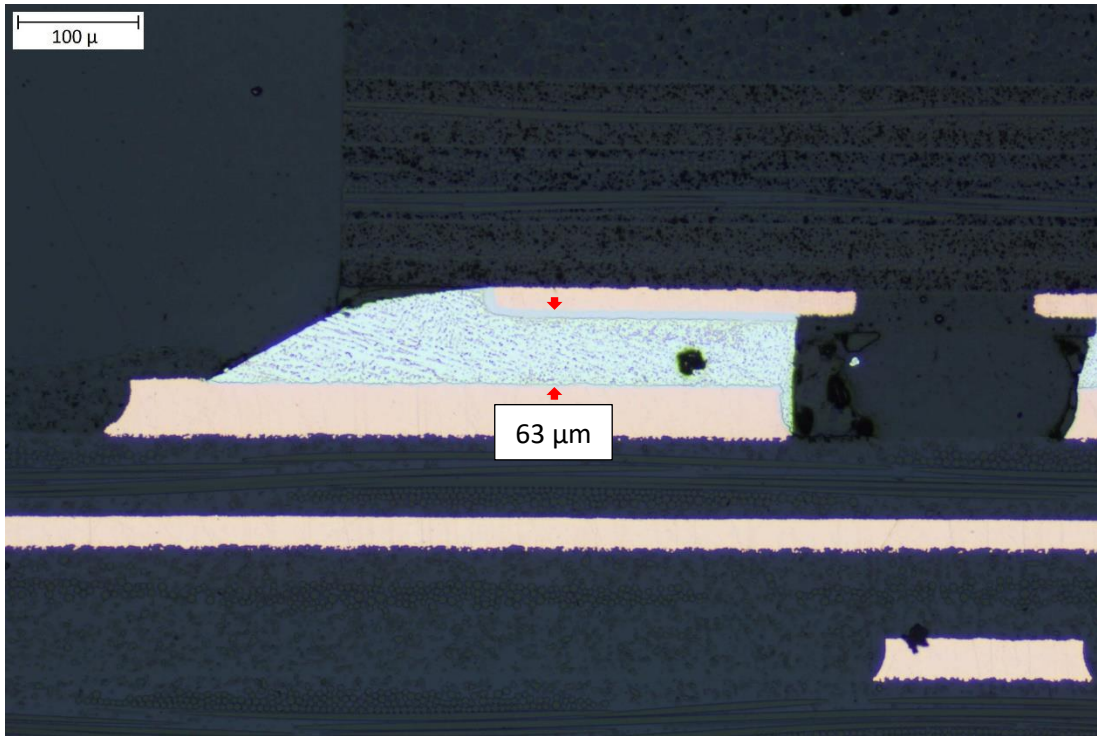
Figure 43. Specimen 4LP1 IC7. Standoff height is 63 μm.

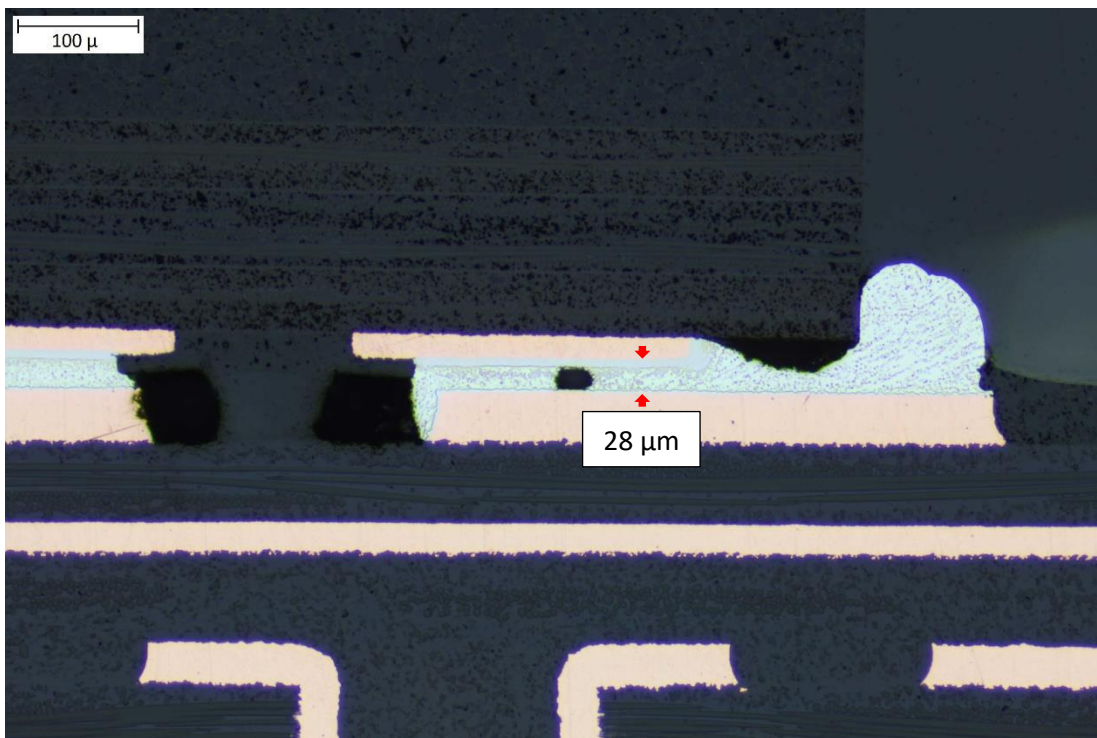
Figure 44. Specimen 4LP1 IC7. Standoff height is 28 μm.
